ACTION MEMORANDUM – RV4

SUBJECT: Request for Approval of a Ceiling Increase and 12-Month Exemption for CERCLA Removal Action at the Deferiet Paper Mill Site, Village of Deferiet, Jefferson County, New York

Site ID No.: A26F

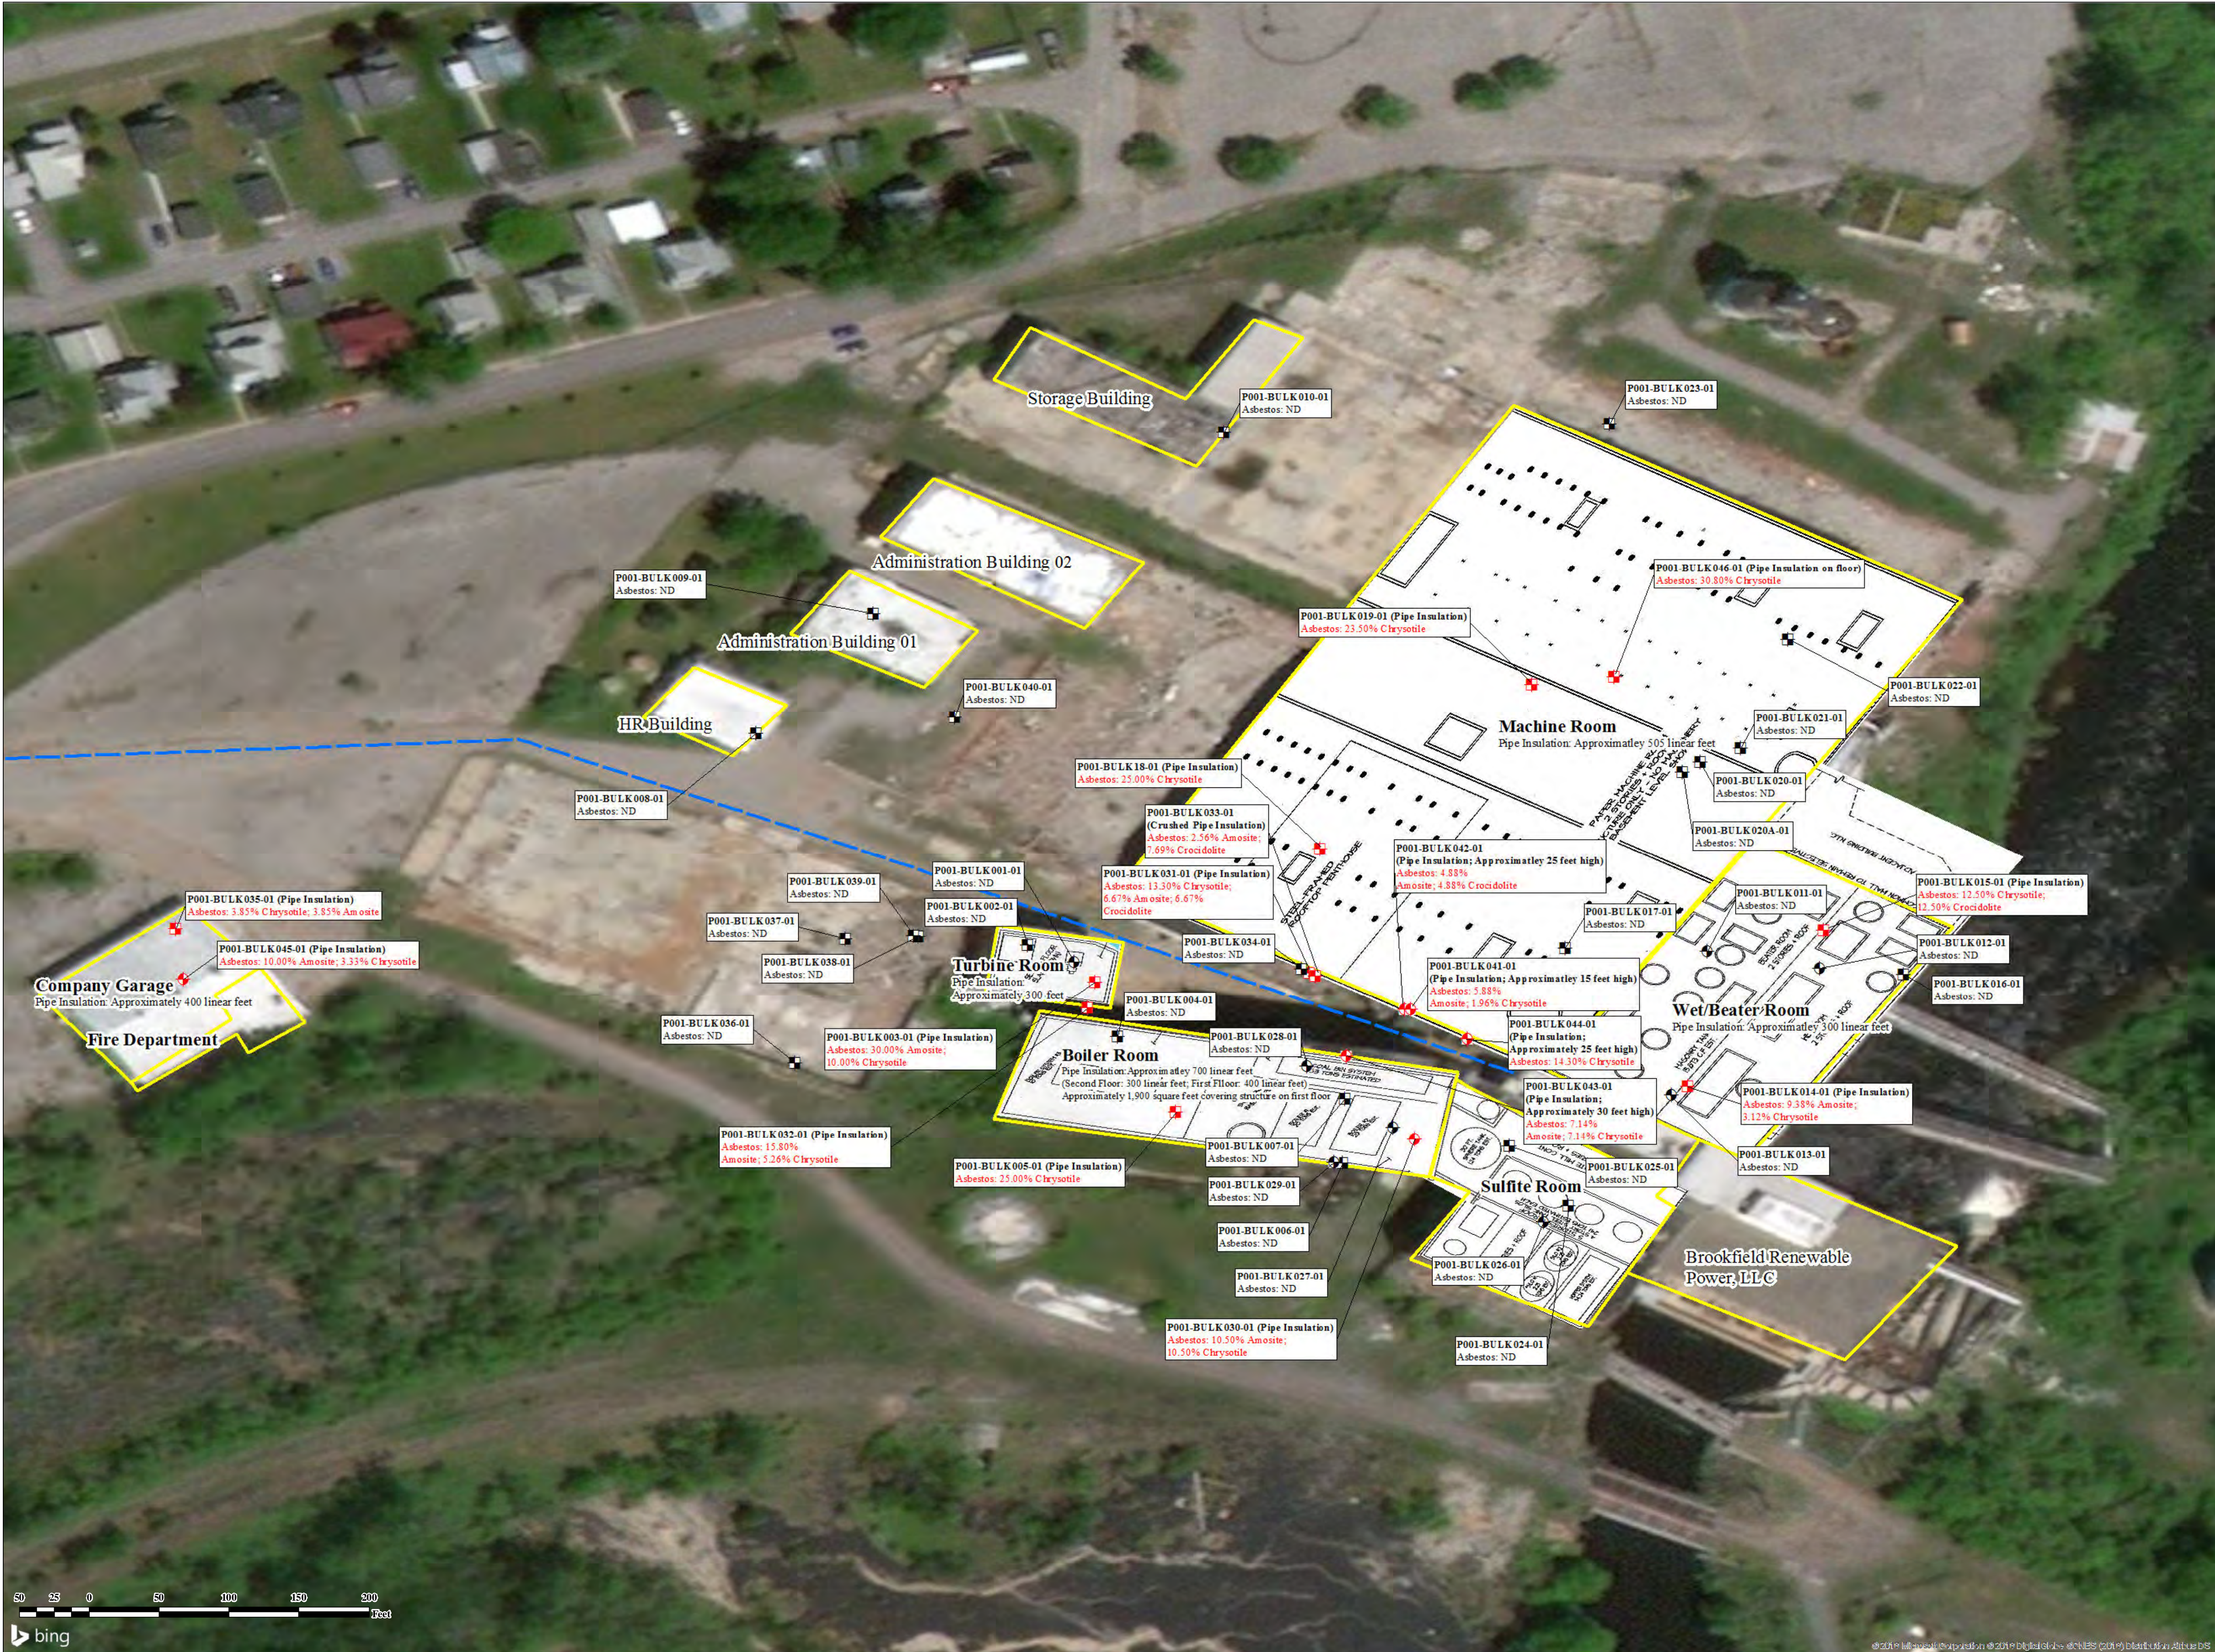
Bulk SACM Results Map June 2017 and May 2018 Removal Assessments

- SACM Samples Collected from the First Floor and from Ground Level- No Asbestos Detected.
- SACM Samples Collected from the Second Floor - No Asbestos Detected
- SACM Samples Collected from the First Floor and Ground Level - Asbestos Detected.
- SACM Samples Collected from the Second Floor and from Elevated Locations - Asbestos Detected

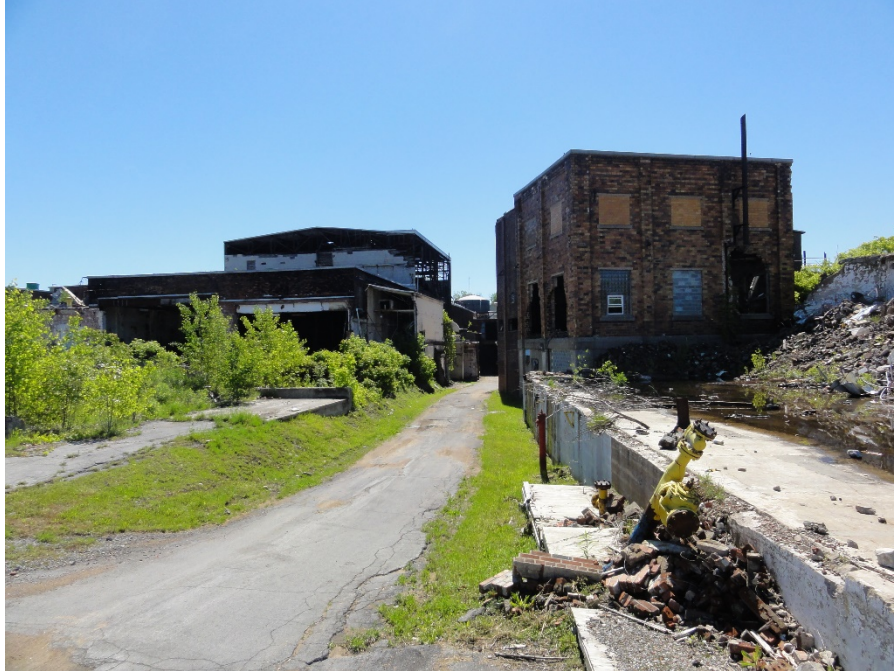
View facing southeast of the machine room (left) and turbine room (right). Some of the partially demolished walls of the turbine room can be seen.

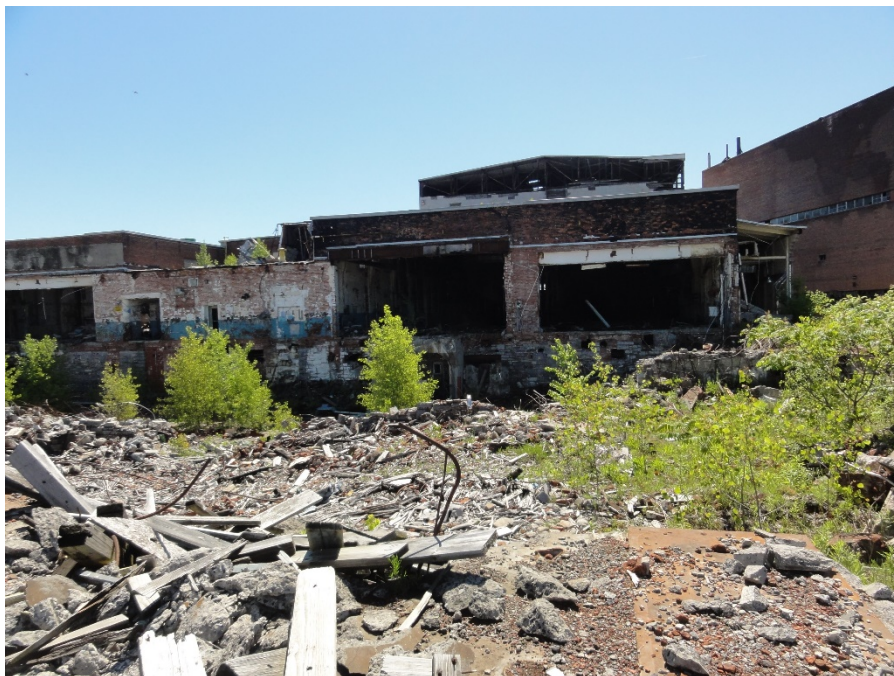
View facing southeast of the machine room. Some of the partially demolished walls of the machine room can be seen.

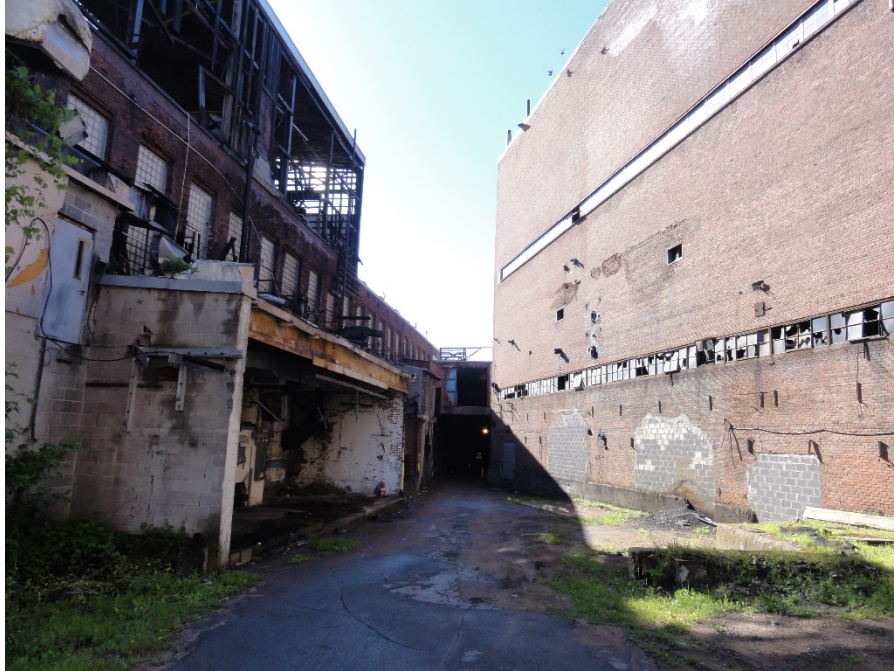
View of the alleyway that is traversed by Brookfield personnel to enter their power generation facility. ACM within this alleyway was encapsulated during RV1 and RV3.

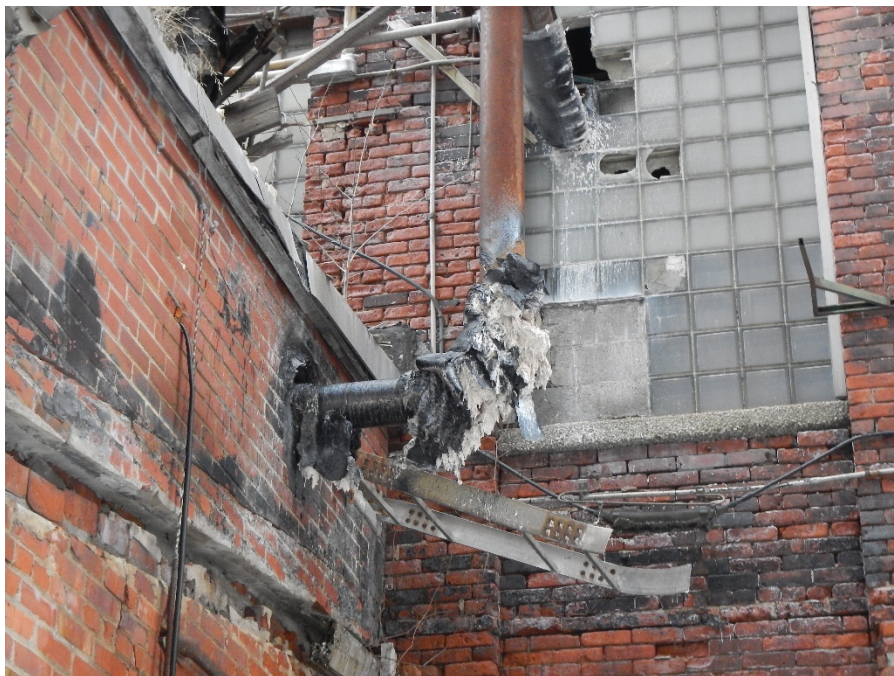
In September and October 2018, Brookfield informed EPA that the encapsulant used during RV1 was continuing to deteriorate, exposing larger areas of ACM within the alleyway. Brookfield personnel indicated that this area is traversed daily to access the hydropower facility. In October 2018, EPA activated and mobilized ERRS contractors to apply additional sealant on asbestos-containing pipe insulation exposed in the alleyway area to temporarily protect Brookfield employees and the public. This work (RV3) was completed on October 17, 2018.

Deteriorating ACM encapsulant within the alleyway. The encapsulant begins to deteriorate within a year or two of application.

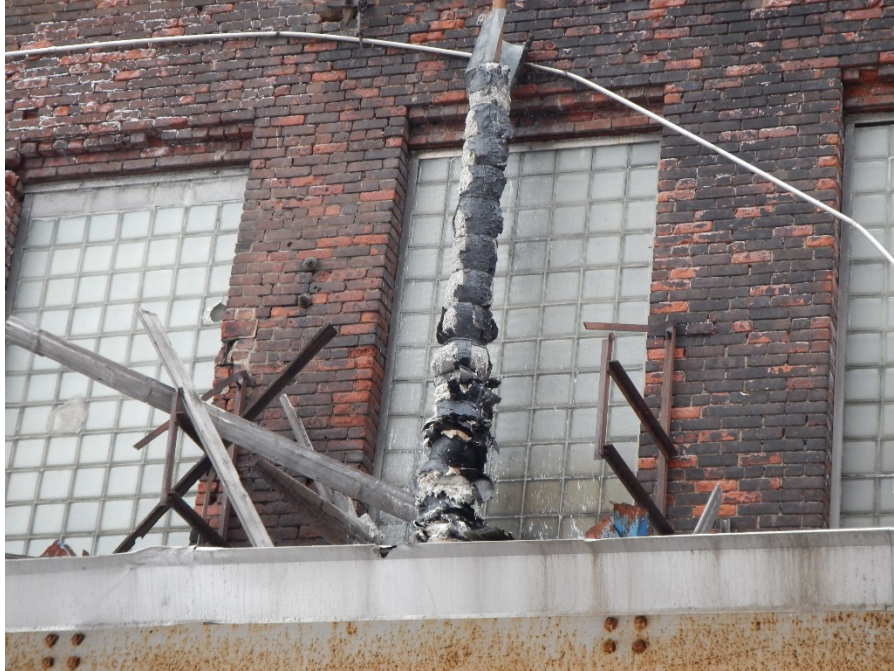
Additional deteriorating ACM encapsulant within the alleyway.

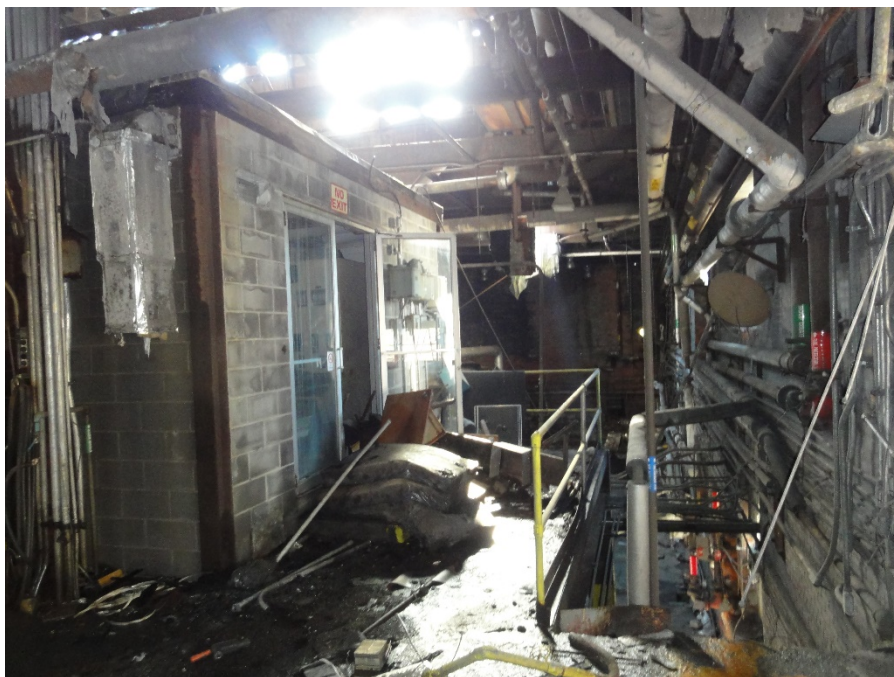
Inside of the boiler room. Asbestos insulation is exposed to weathering and has an egress due to the collapsed roof.

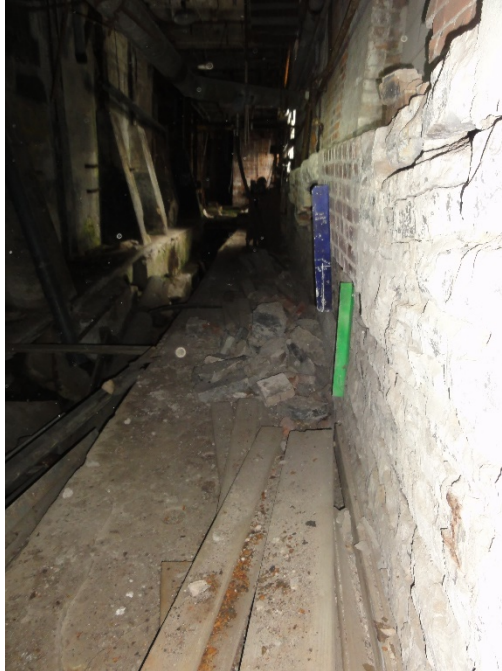
Inside of the wet/beater room where the wall is bowing. If this collapses there will be a release of asbestos into the air and Black River channel.

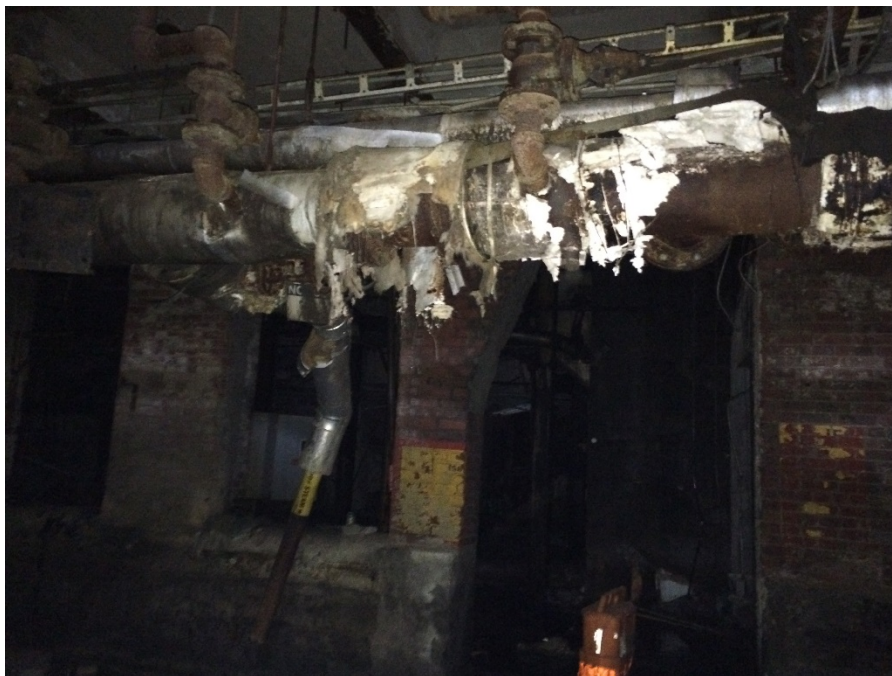
Deteriorating ACM in the wet/beater room. This is the typical asbestos insulation found throughout the wet/beater room, machine room, turbine room, and boiler house.
